**RESEARCH  
REPORT  
NO.90-1**

# **Membrane and Flashing Condition Indexes for Built-Up Roofs Volume II: Inspection and Distress Manual**

**by  
Mohamed Y. Shahin  
David M. Bailey  
Donald E. Brotherson**

**Building Research Council, University of Illinois, Champaign, IL  
In cooperation with the US Army Corps of Engineers  
Construction Engineering Research Laboratory**

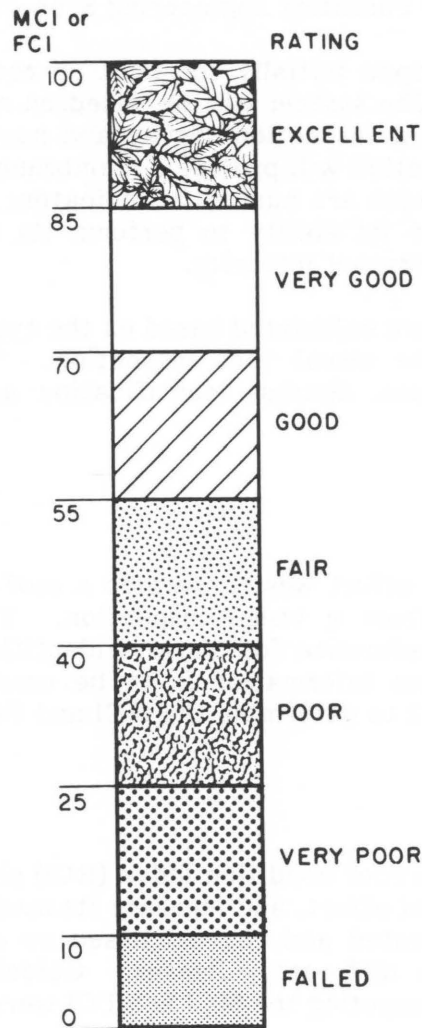
Figure 1. Membrane and Flashing Condition Indexes (MCI and FCI) and ratings.

The results of the roof inspection are to be used in conjunction with procedures in Chapter 2 to determine the MCI and FCI and their respective ratings (Figure 1). Deduct value curves are in Appendix A. A sample of the sheets to be used by the roof inspectors is provided in Appendix B.

5. Determine the condition ratings from Figure 1.

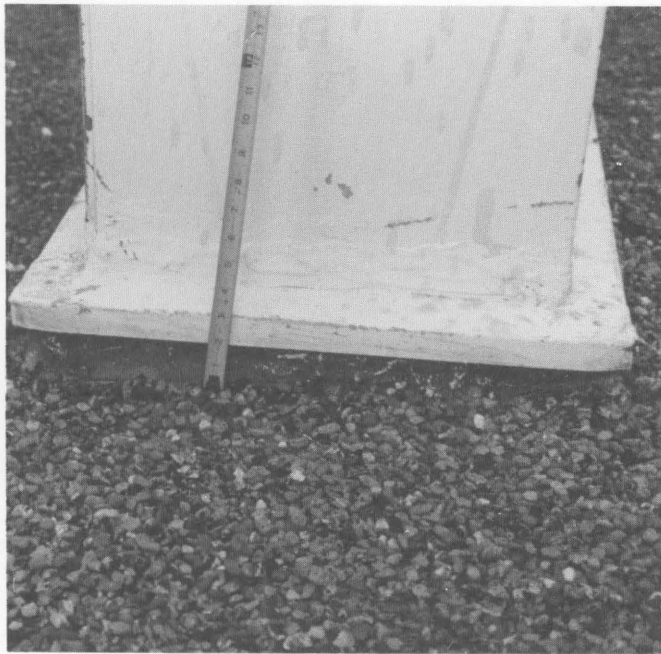
Figure 5. Check height of base flashing above deck.

Measure height of top termination of base flashing above the roof surface (Figure 5). To establish the height, run fingers up behind the counterflashing. If the base flashing height cannot be determined, assume it is adequate (Figure 6).

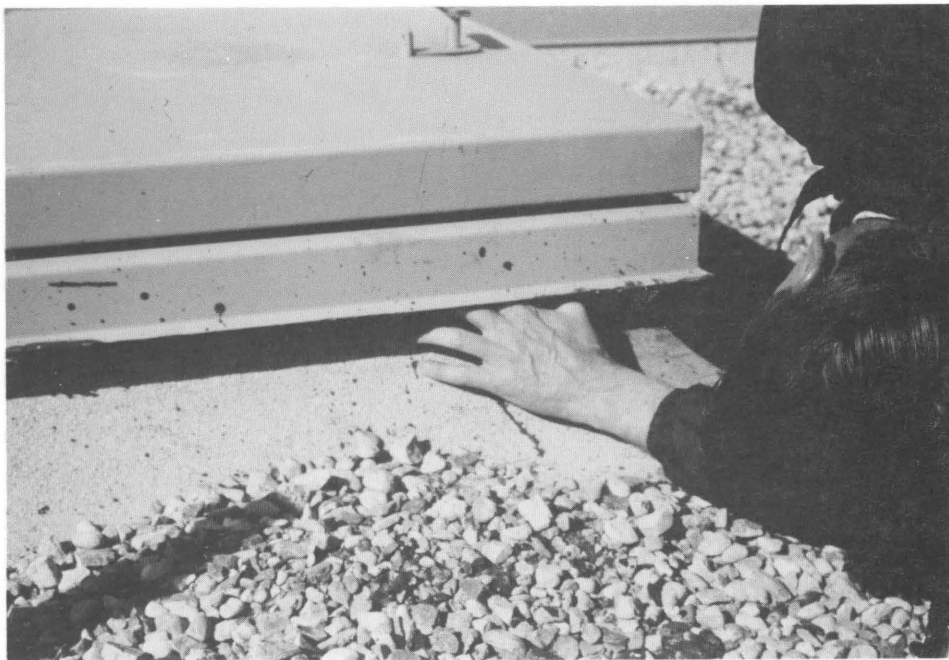
Figure 6. Check base flashing height by running fingers behind counterflashing.

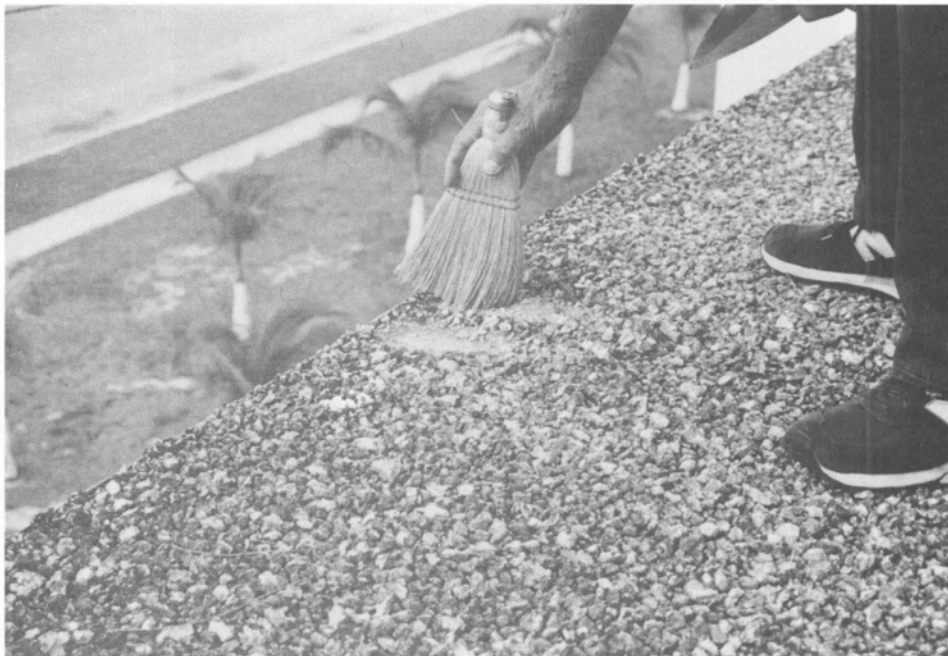
Figure 7. Sweep gravel back from embedded edge metal to expose joints.

Determine the total number of joints by dividing the total length of embedded edge metal flashing by the length of the edge metal sections (normally 10 ft). Inspect every fourth joint for splits in the stripping felts, removing any loose gravel or dirt from the joint using the small whisk broom and pointing trowel (Figure 7). Determine the number of inspected joints that are high severity (have splits in the stripping felts [Figure 8]) and multiply by 4 to get the total number of high severity joints (one joint equals 1 ft). All other joints are considered medium severity. Multiply the number of inspected joints not counted as high severity by 4 to obtain the total number of medium severity joints. Check that the embedded edge metal flashing is secure by attempting to lift the outside edge.

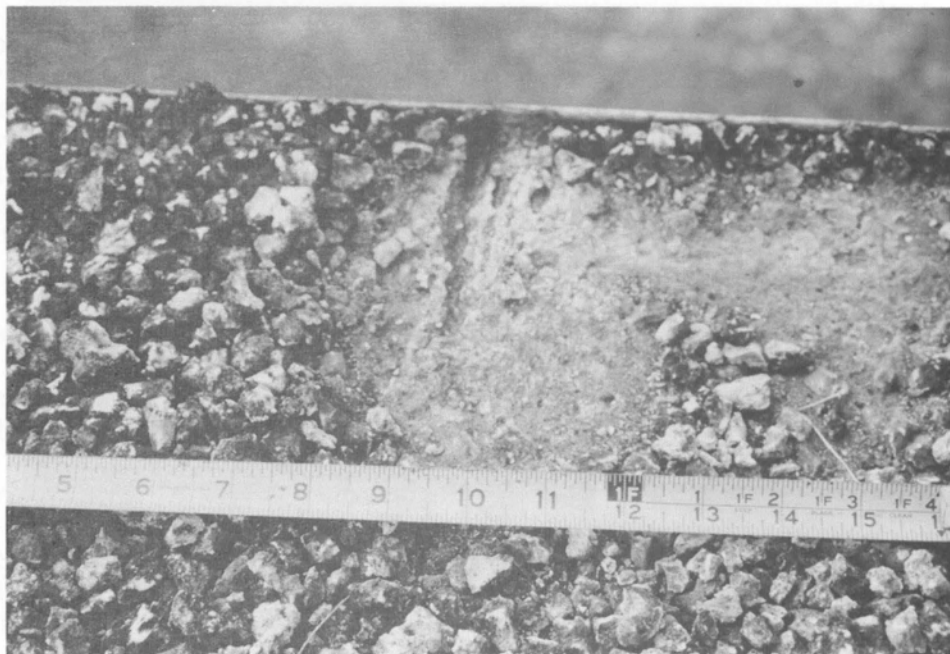
Figure 8. Tear in stripping felts exposed by sweeping gravel away at joints.

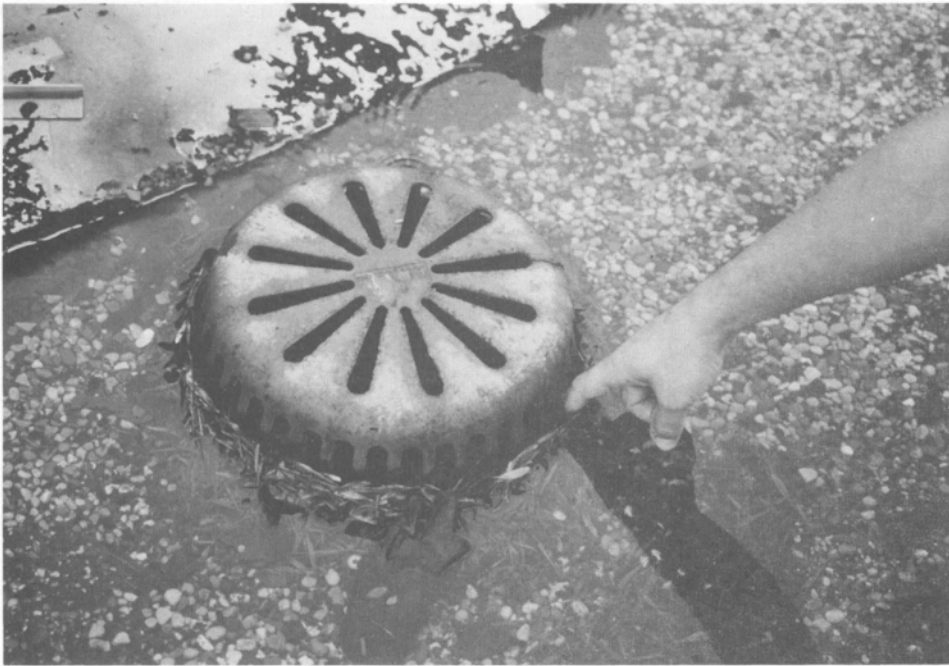
**Figure 9. Roof drain clogged by debris.**

Check all drains and scuppers and remove debris whenever possible (Figures 9 and 10). When inspecting drains, make sure the clamping ring is tight. Stripping felts around scuppers should be inspected for holes at corners.

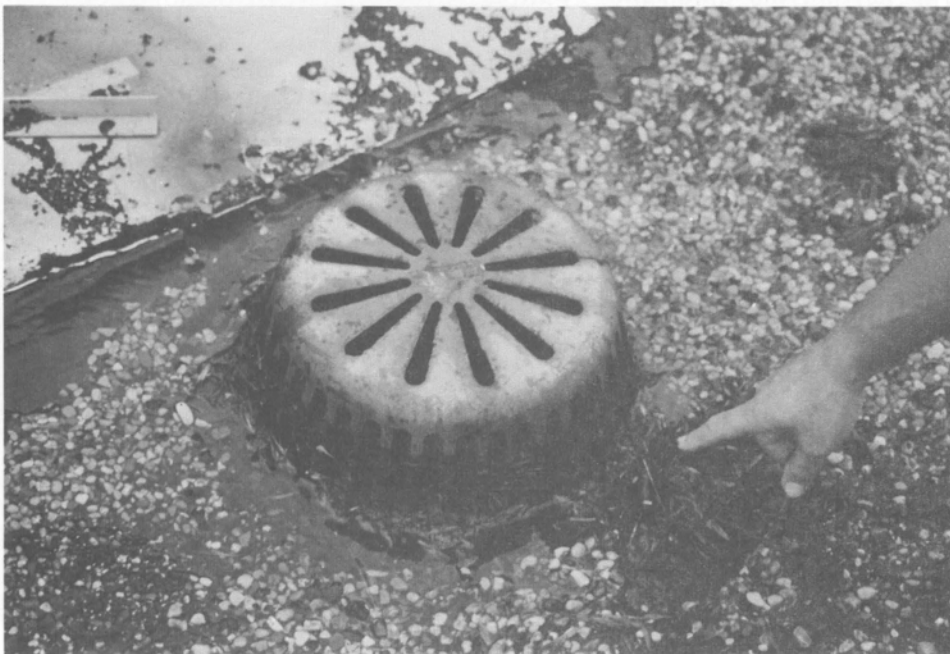
**Figure 10. Removing debris frees the drain.**

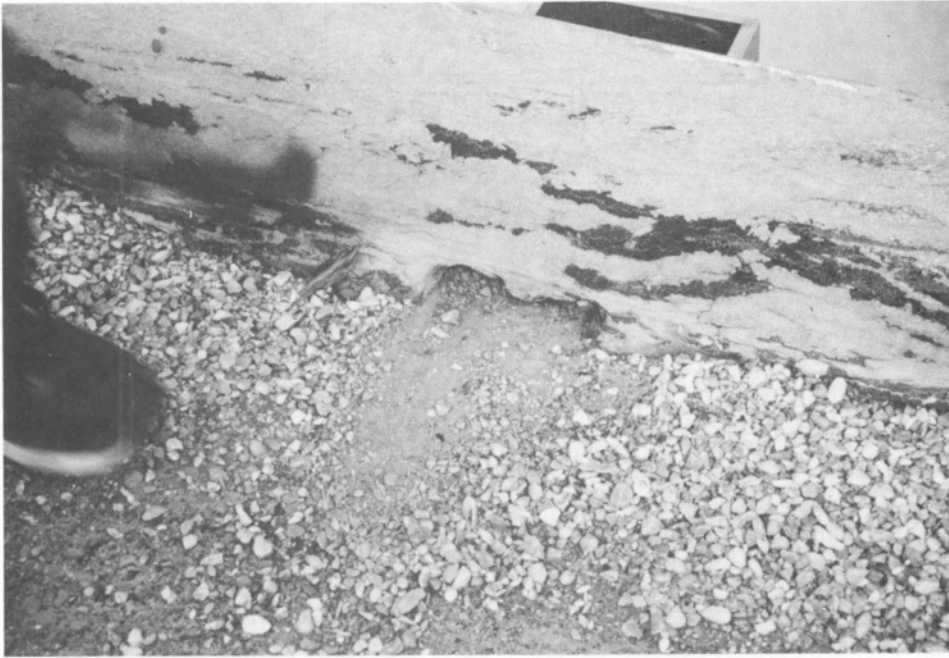
**Figure 11.** Scupper opening is too small and easily clogged. Report in the "Remarks" section on the back of the Roof Inspection Worksheet.

- Be careful not to damage the roof. Do not step on blisters, kick base flashing or step on edge flashing.
- Note existing problems that are not included in the lists of flashing and membrane distresses in the "remarks" section on the back of the worksheet. Figures 11 and 12 show examples of these problems. Walk the outside of the building and look for water stains, efflorescence, missing mortar, spalled brick, and gutter and drainage problems.

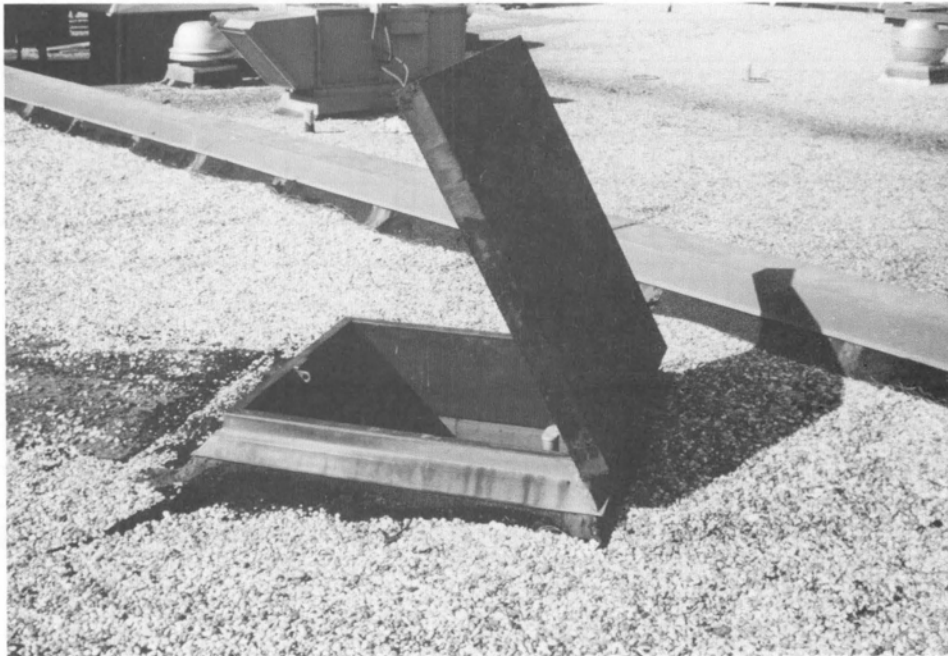
**Figure 12.** Metal curb around scuttle is corroded and needs paint. Report in the "Remarks" section.

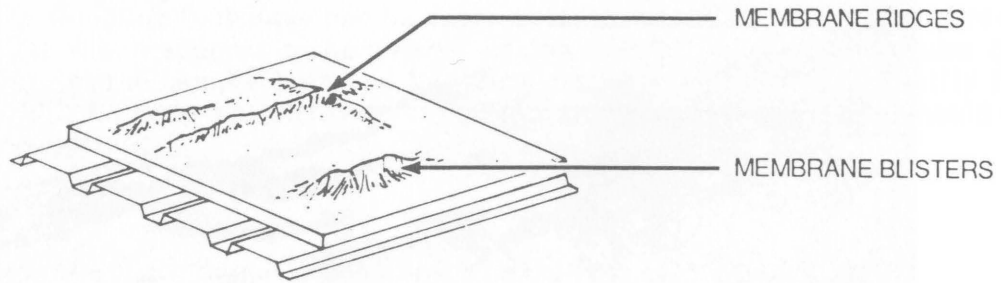
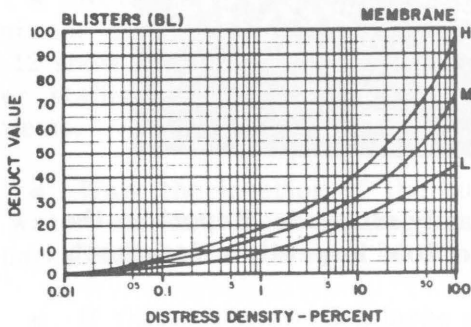
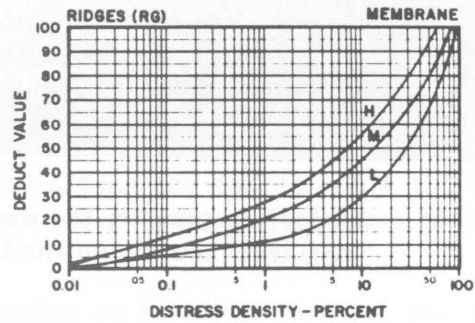
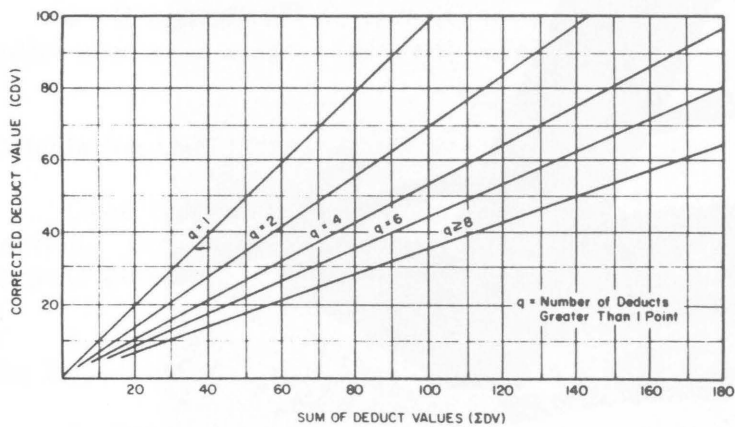
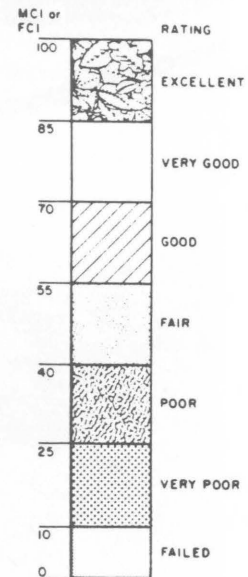
STEP 1. INSPECT ROOF. DETERMINE DISTRESS TYPES AND SEVERITY LEVELS;  
DETERMINE QUANTITIES AND CALCULATE DENSITIES.

STEP 2. DETERMINE DEDUCT VALUES.

STEP 5. DETERMINE MEMBRANE  
CONDITION RATING.

STEP 3. COMPUTE CORRECTED DEDUCT VALUE.

STEP 4. COMPUTE MEMBRANE CONDITION INDEX (MCI) = 100-CDV

Figure 13. Steps for determining roof membrane condition rating.

Once the condition survey is completed, determine the FCI and MCI for the roof section. Calculating the condition indexes is a simple procedure which involves five steps (Figure 13).

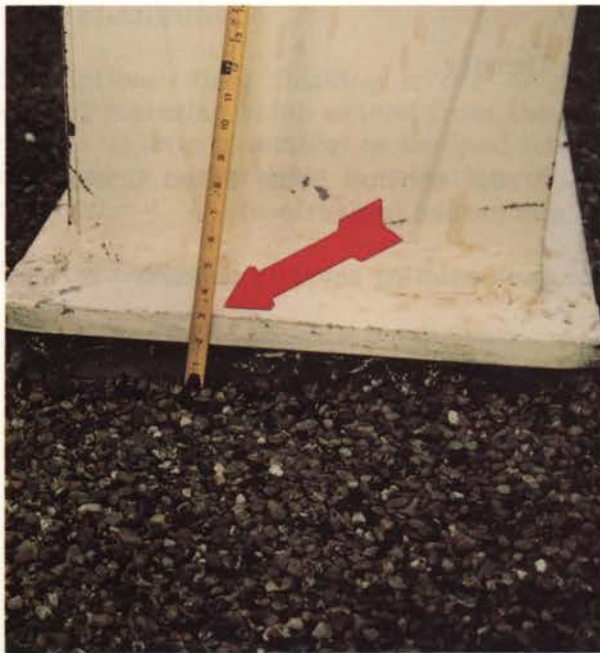
BF1 Base Flashing  
 <Low Severity>  
 Curb is not high enough--  
 6 in. minimum

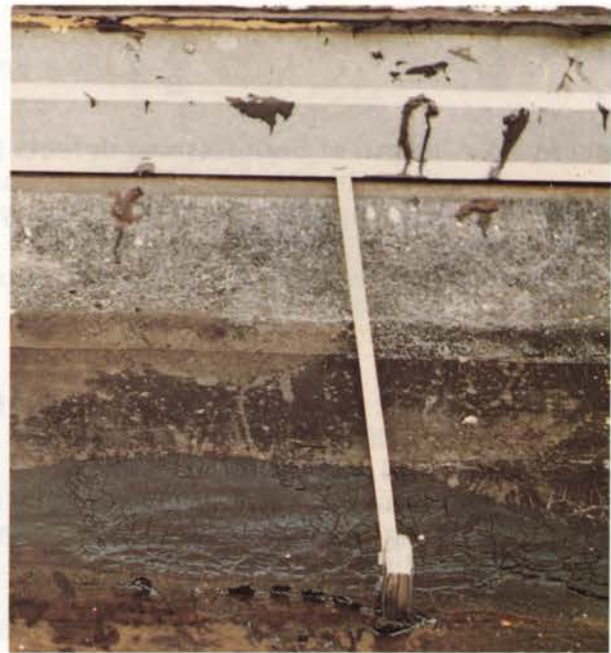
BF2 Base Flashing  
 <Low Severity>  
 Surface looks poor but there are  
 no areas that are worn through

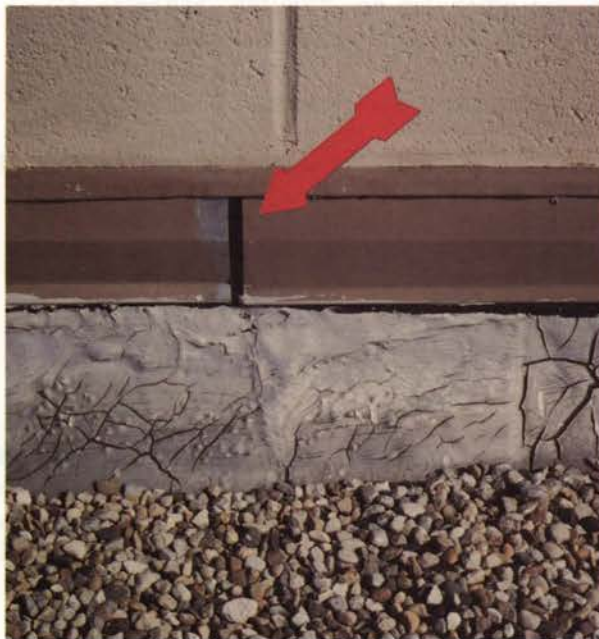
BF3 Base Flashing  
 <Low Severity>  
 Poor appearance of coating but coating  
 is not worn through. Also, counter-  
 flashing is displaced <High Severity>

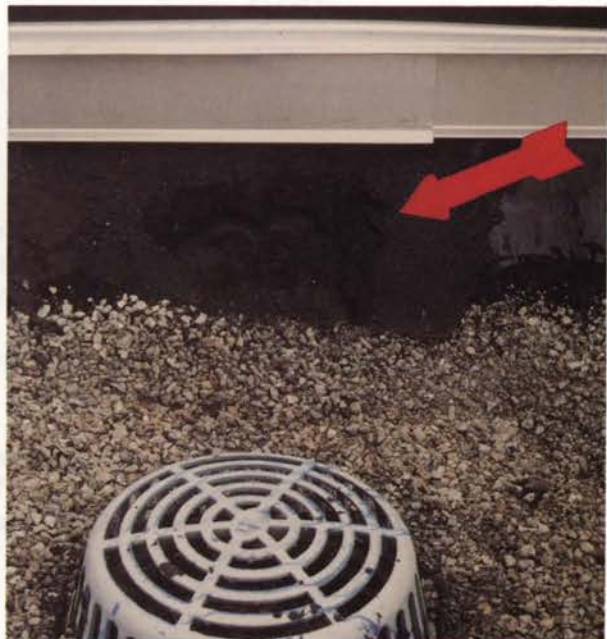
BF4 Base Flashing  
 <Low Severity>  
 Mineral surfacing is worn but  
 surface is still intact

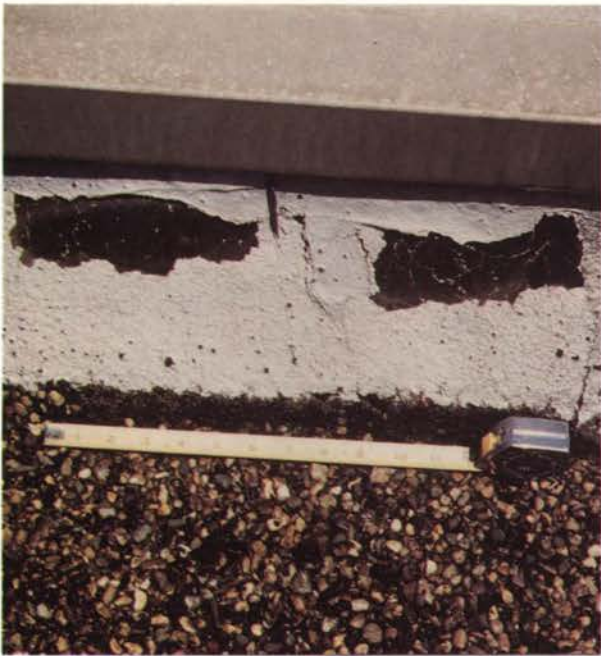
**BF5** Base Flashing  
<Medium Severity>  
 Surfacing is worn but hole is not all the way through the flashing

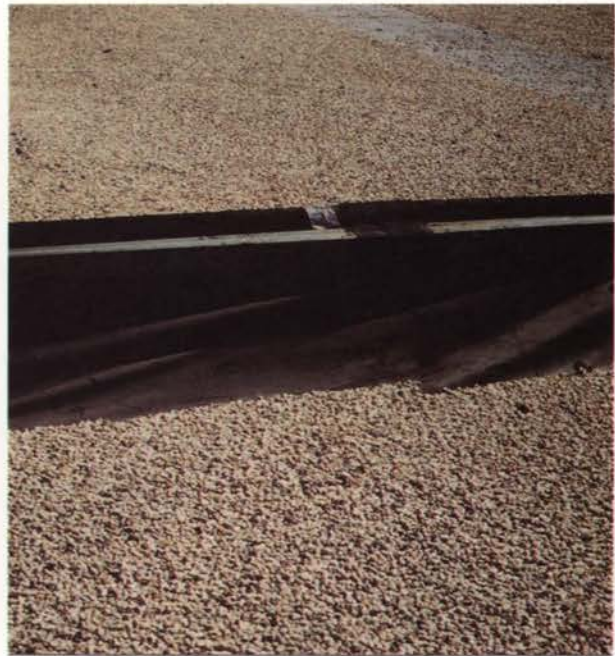
**BF6** Base Flashing  
<Medium Severity>  
 Base flashing is pulled and not firmly bonded to the curb

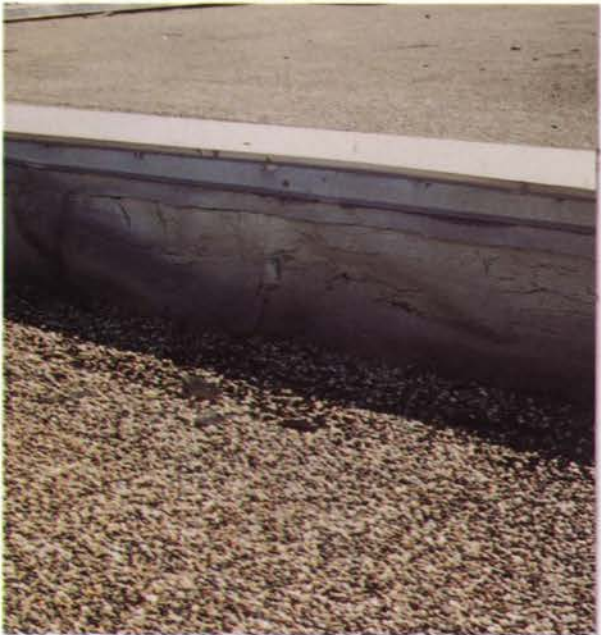
**BF7** Base Flashing  
<Medium Severity>  
 Flashing material has sagged

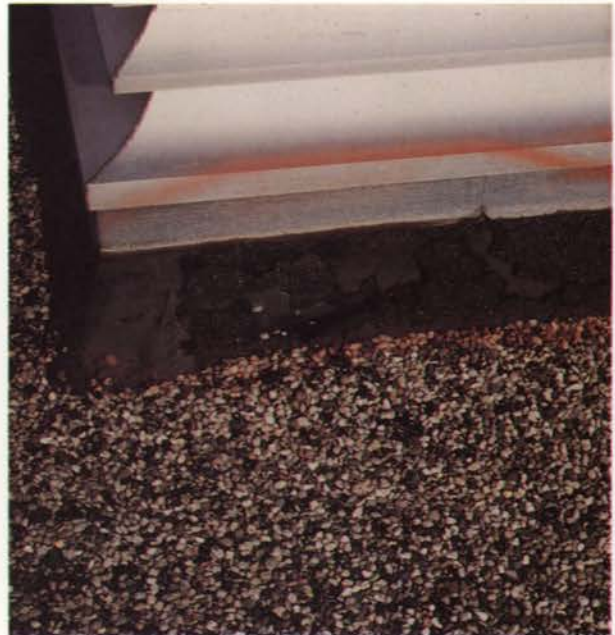
**BF8** Base Flashing  
<High Severity>  
 Deteriorated flashing material; there are holes through all piles of the flashing

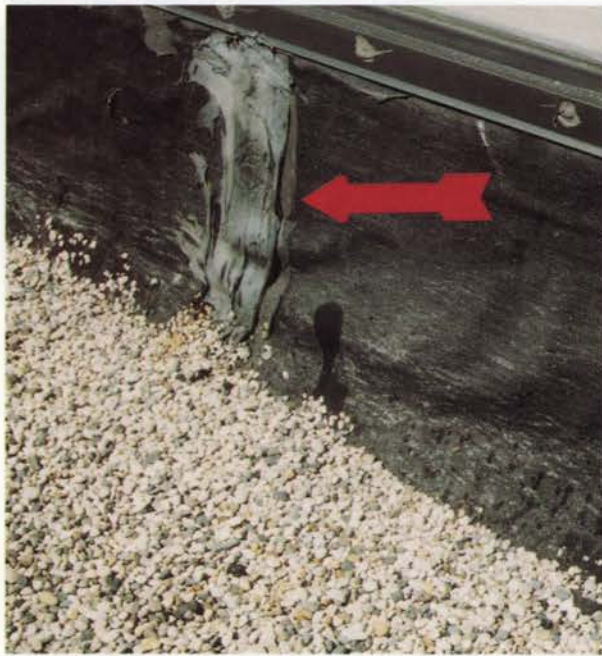
BF9 Base Flashing  
<High Severity>  
 There is an open seam and the material has sagged

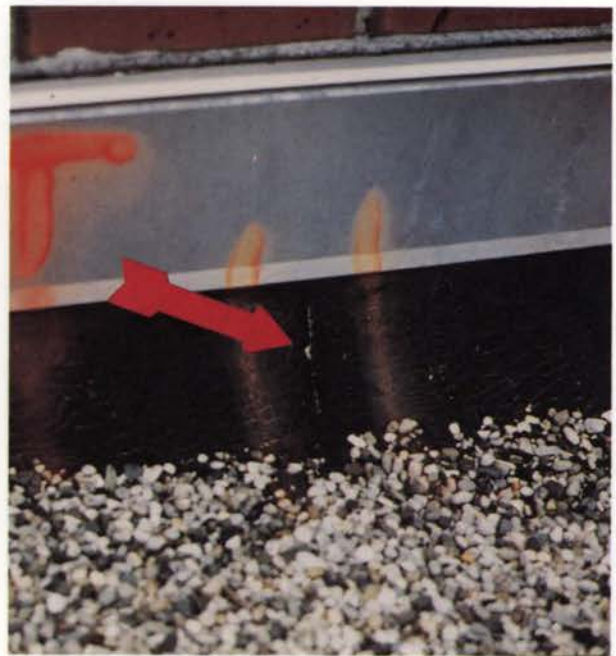
BF10 Base Flashing  
<High Severity>  
 There is an open seam in the flashing

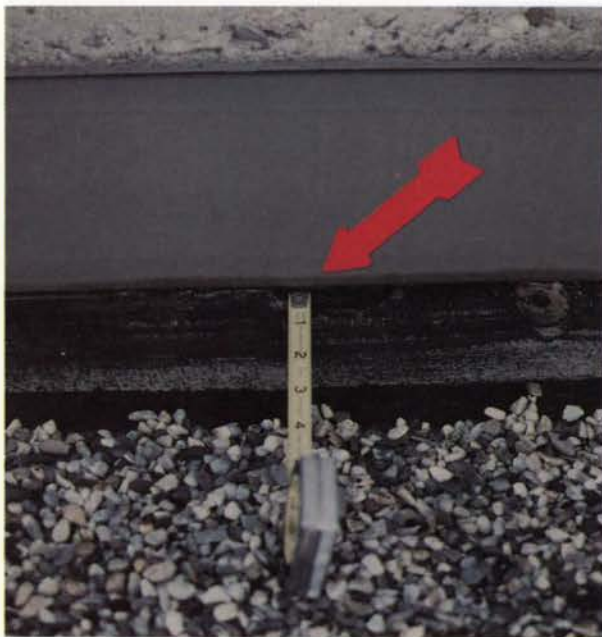
BF11 Base Flashing  
<High Severity>  
 Flashing has sagged; top is open

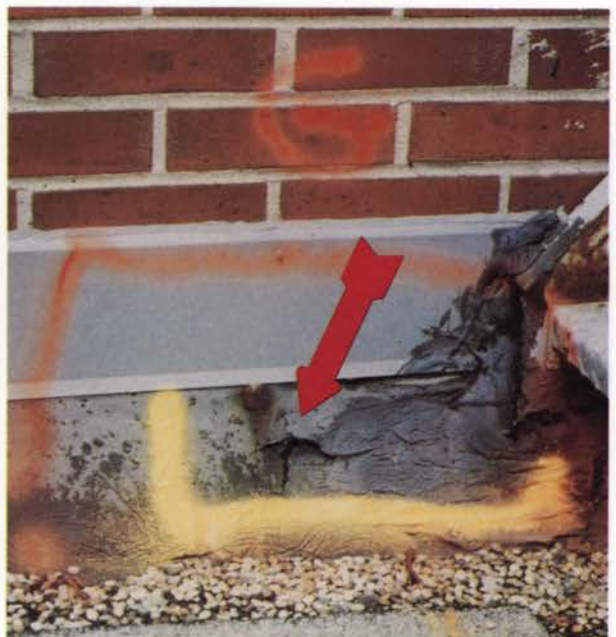
BF12 Base Flashing  
<High Severity>  
 There is a hole through the flashing material

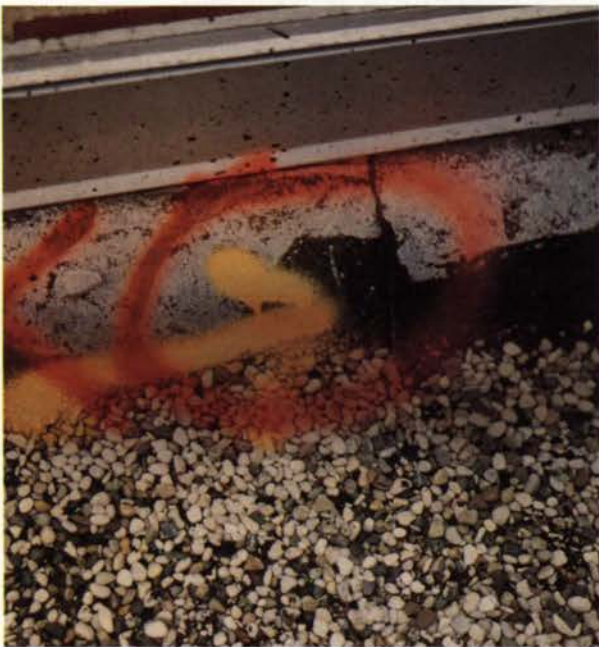
BF13 Base Flashing  
 <High Severity>  
 There is an open seam in the  
 flashing

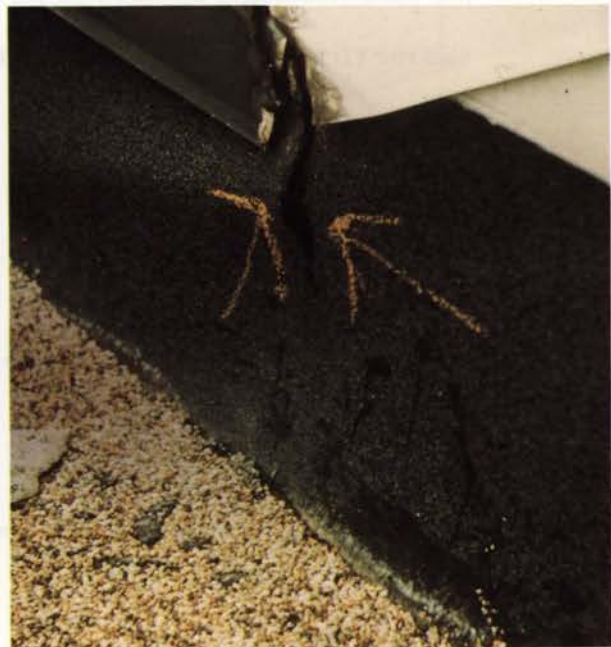
BF14 Base Flashing  
 <High Severity>  
 There is a hole in the flashing  
 material

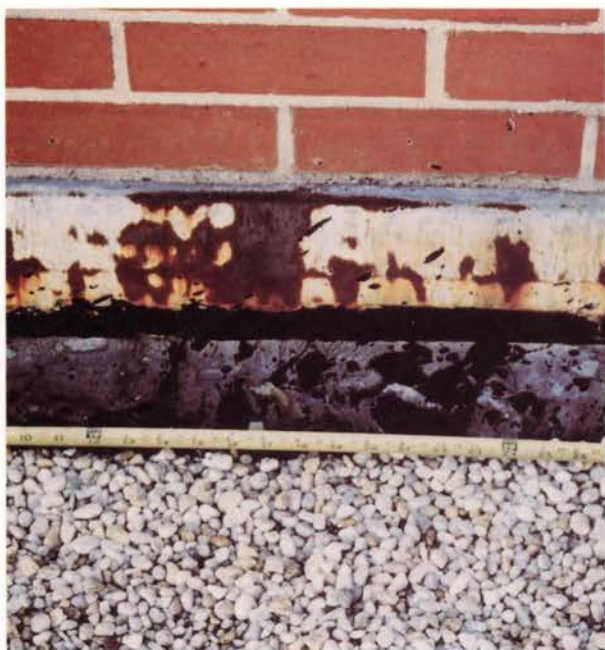
MC1 Metal Cap Flashing  
 <Low Severity>  
 The metal has begun to corrode but  
 no holes are evident

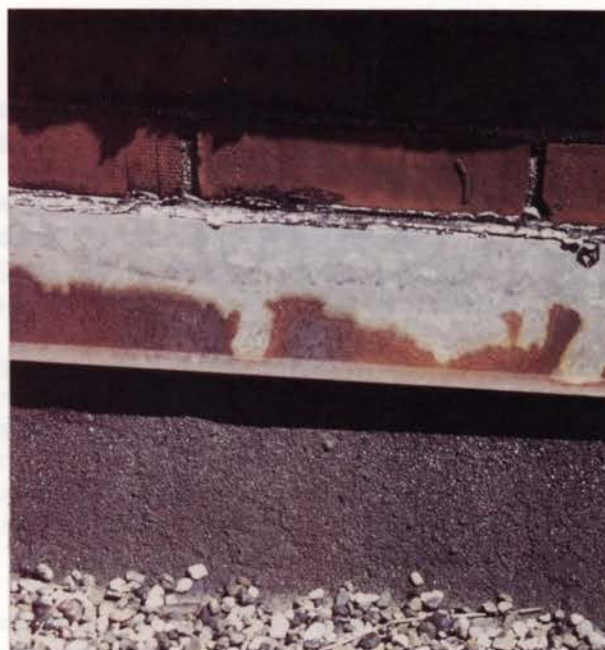
MC2 Metal Cap Flashing  
 <Low Severity>  
 The metal is bent but still func-  
 tions; there is some corrosion

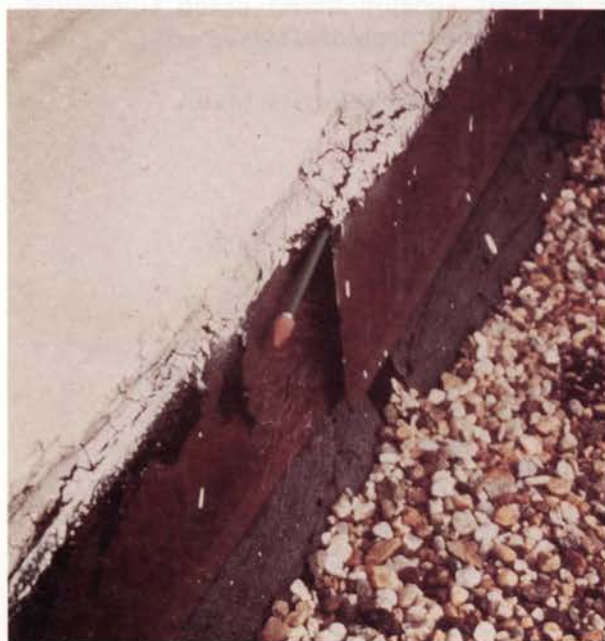
MC3 Metal Cap Flashing  
 <Low Severity>  
 The metal is bent but still is able  
 to function

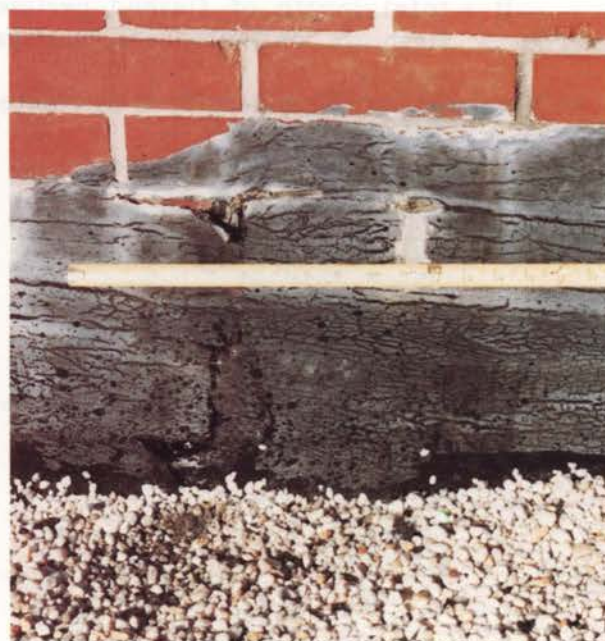
MC4 Metal Cap Flashing  
 <Low Severity>  
 The counterflashing has been  
 sealed to the base flashing

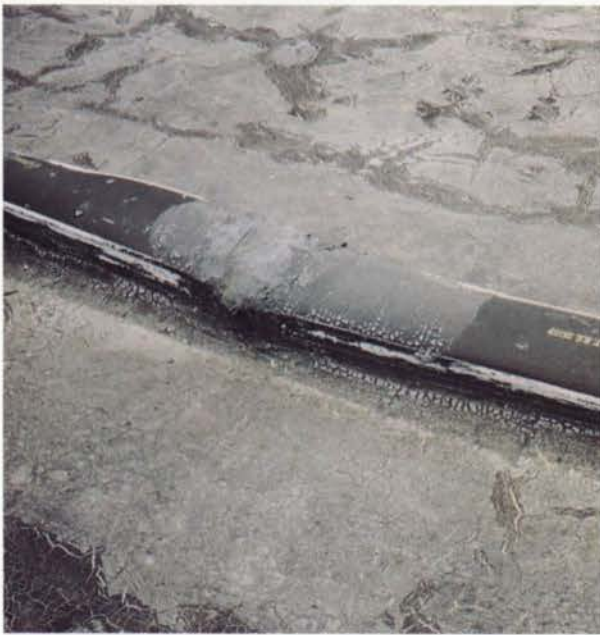
**MC5 Metal Cap Flashing**  
 <Low Severity>  
 Metal or accessories have been deformed or damaged

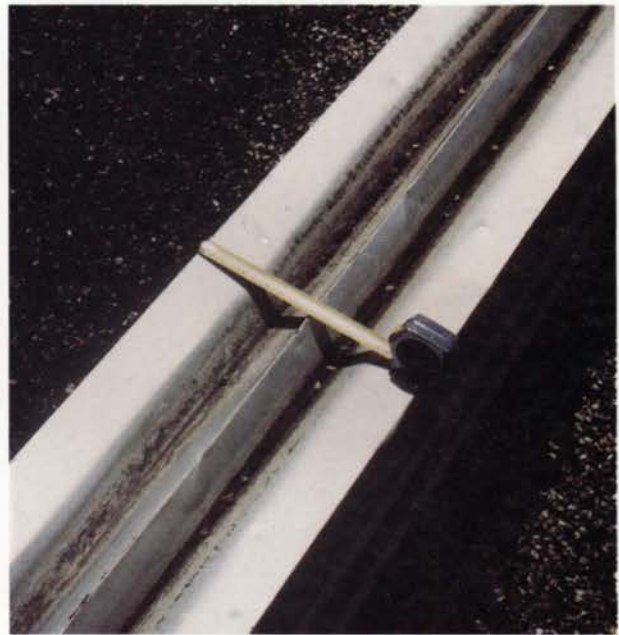
**MC6 Metal Cap Flashing**  
 <Low Severity>  
 Water can accumulate on top of the cap

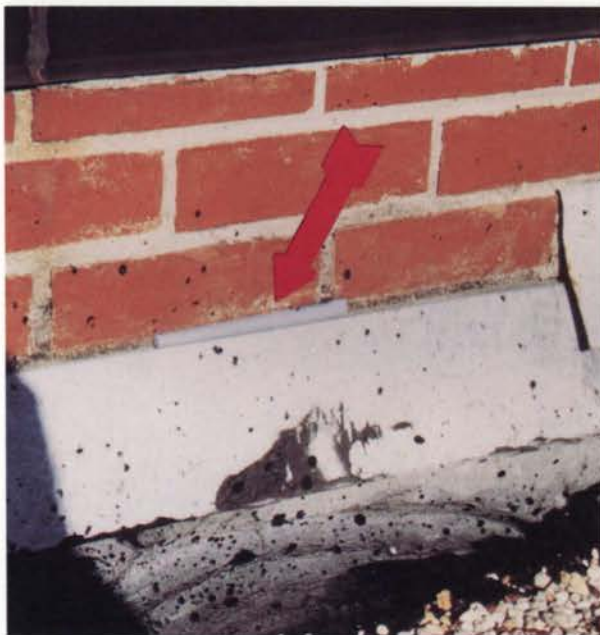
**MC7 Metal Cap Flashing**  
 <Medium Severity>  
 The metal has been bent so that water can accumulate on the joint in the masonry

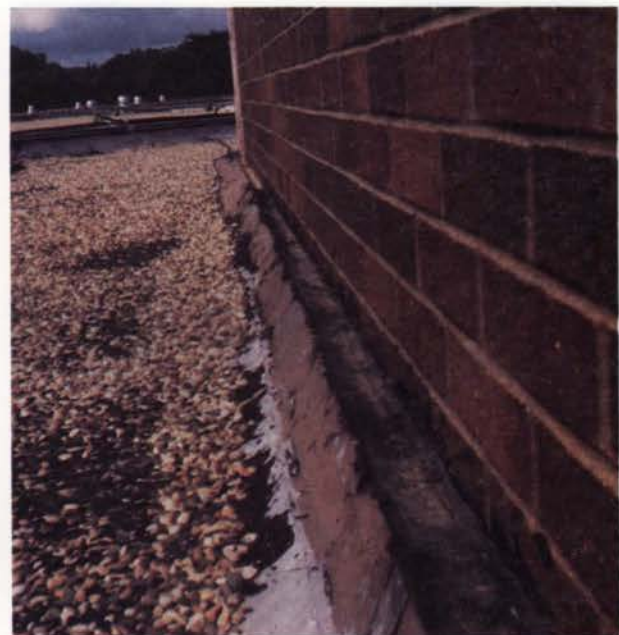
**MC8 Metal Cap Flashing**  
 <Medium Severity>  
 The top of the counterflashing holds water

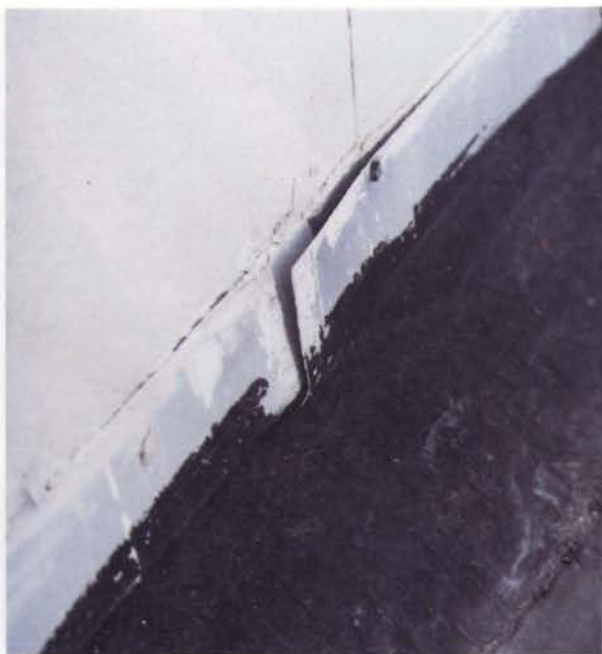
MC9 Metal Cap Flashing  
 <Medium Severity>  
 The top of the counterflashing is loose

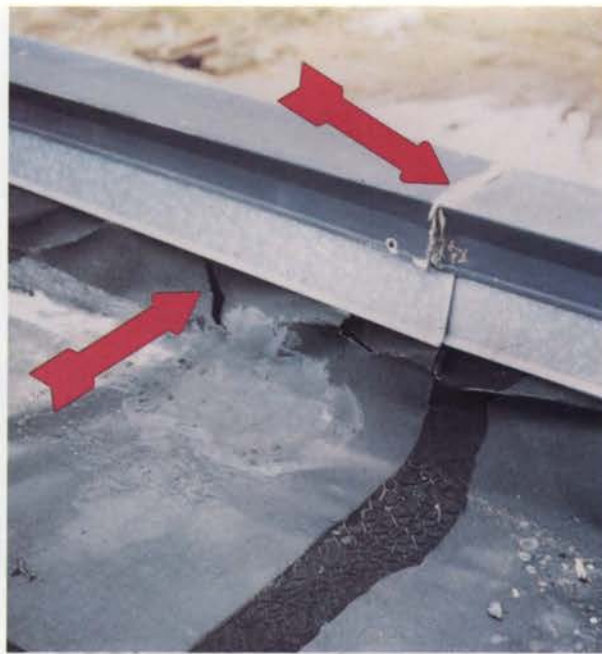
MC10 Metal Cap Flashing  
 <Medium Severity>  
 Joint in cap has failed; caulking has not corrected the problem. Also, Base Flashing has holes <High Severity>

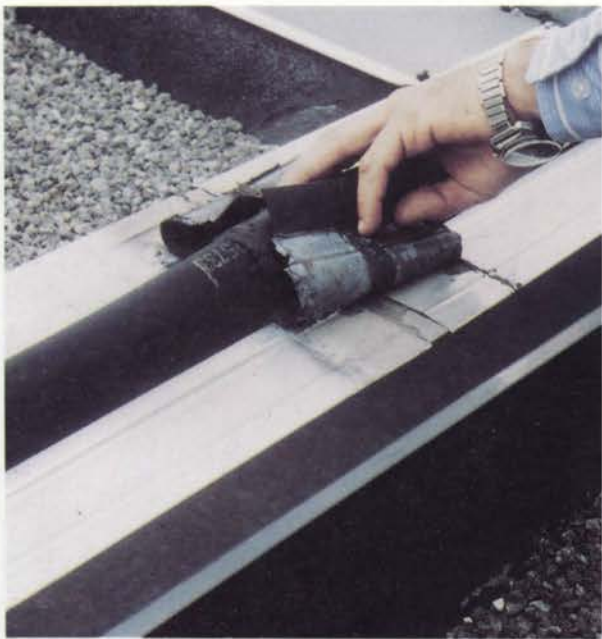
MC11 Metal Cap Flashing  
 <Medium Severity>  
 Neoprene cover at joint has failed

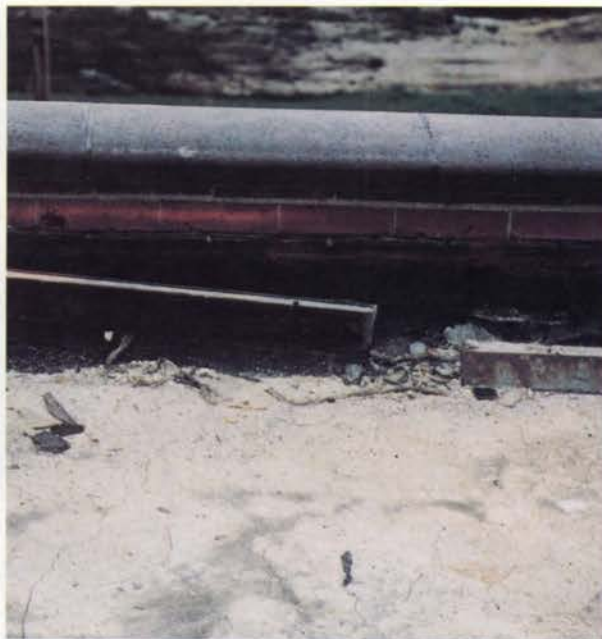
MC12 Metal Cap Flashing  
 <High Severity>  
 The metal counterflashing has fallen off of the wall

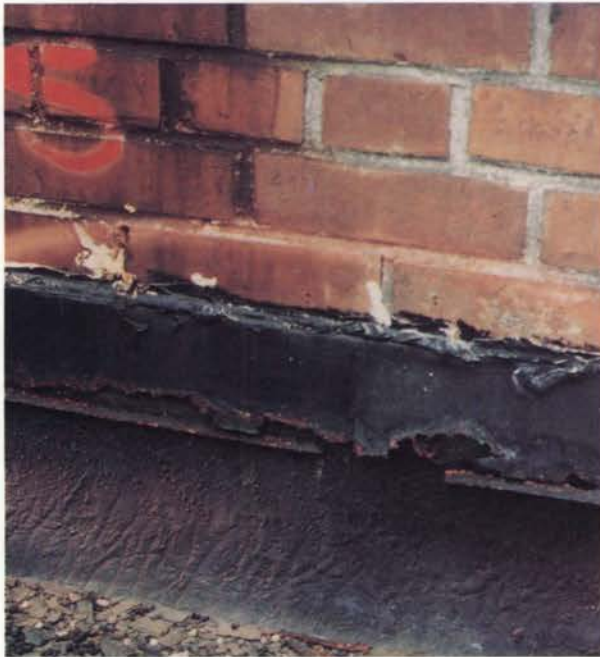
MC13 Metal Cap Flashing  
 <High Severity>  
 The metal has corroded so that there are holes in the metal

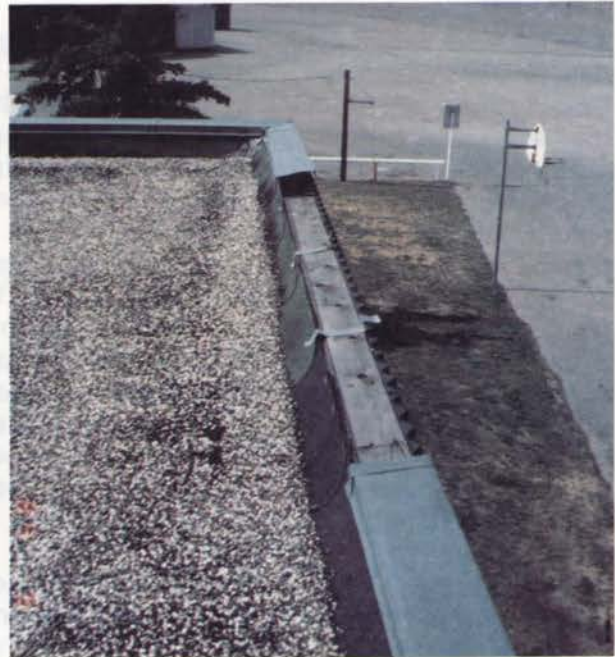
MC14 Metal Cap Flashing  
 <High Severity>  
 Joint covers are missing

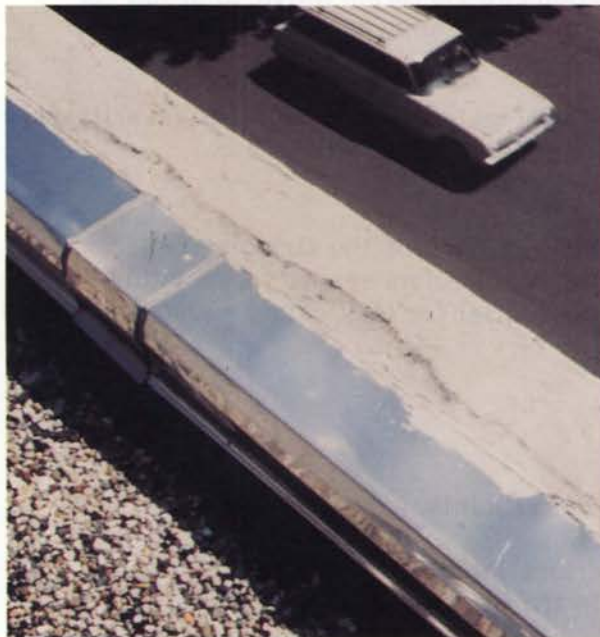
MC15 Metal Cap Flashing  
 <No Severity level--report in remarks>  
 The reglet has been cut into the top of the parapet wall; the caulking has failed

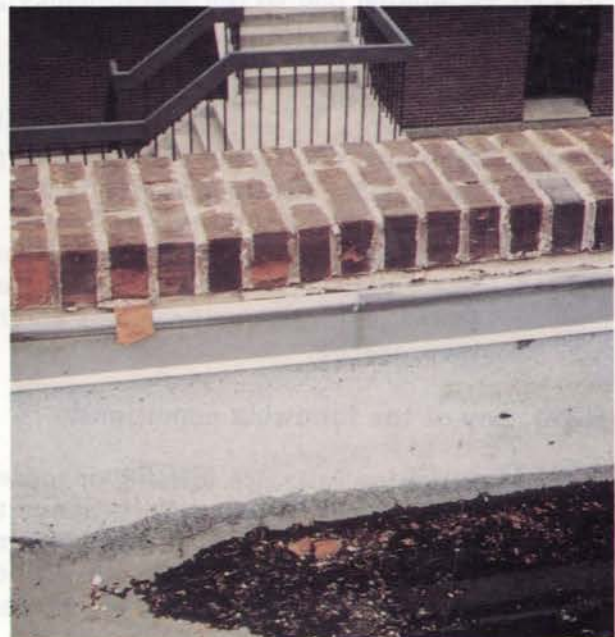
MC16 Metal Cap Flashing  
 <No Severity level--report in remarks> There is no cap flashing; water has penetrated the masonry and deterioration has occurred due to freeze-thaw action

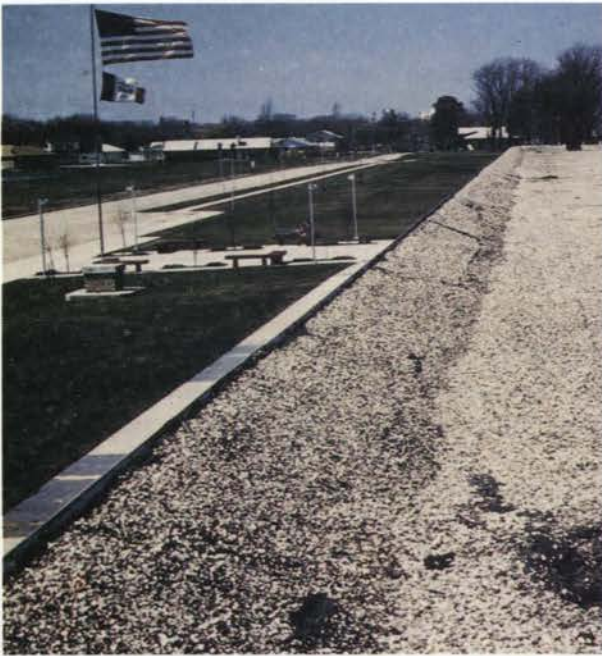
EM1 Embedded Edge Metal  
 <Low Severity>  
 Tapered edge metal is raised but  
 strip-in still presents a potential  
 hazard

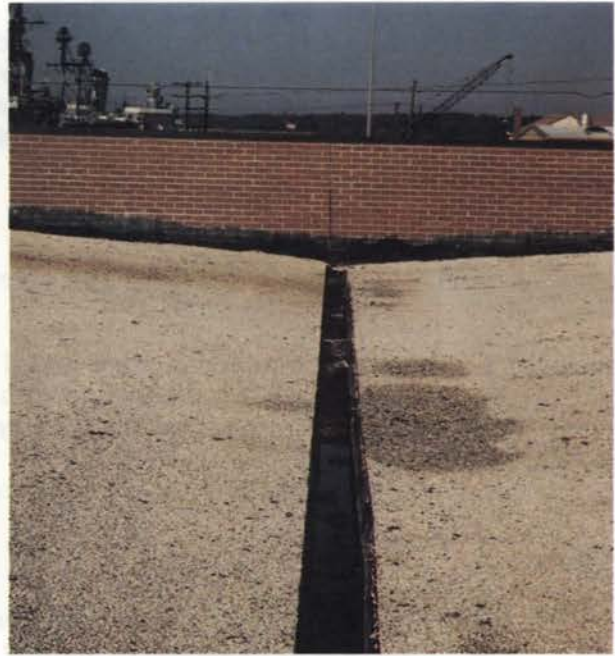
EM2 Embedded Edge Metal  
 <Medium Severity>  
 There are interior gutters

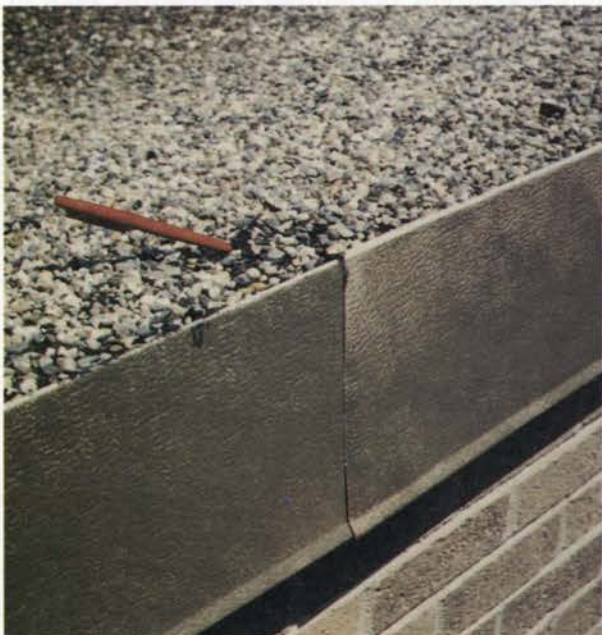
EM3 Embedded Edge Metal  
 <High Severity>  
 The stripping shows the beginning of  
 a tear or break

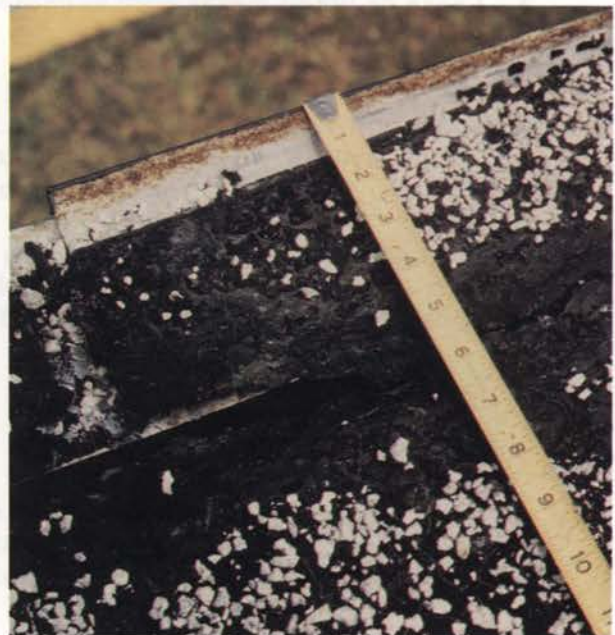
EM4 Embedded Edge Metal  
 <High Severity>  
 The metal is loose or lifted

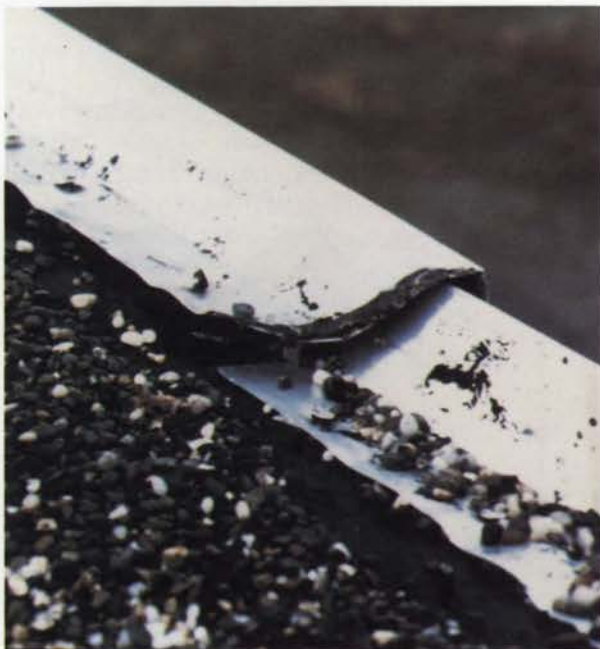
EM5 Embedded Edge Metal  
 <Medium Severity>  
 Stripping felts are missing

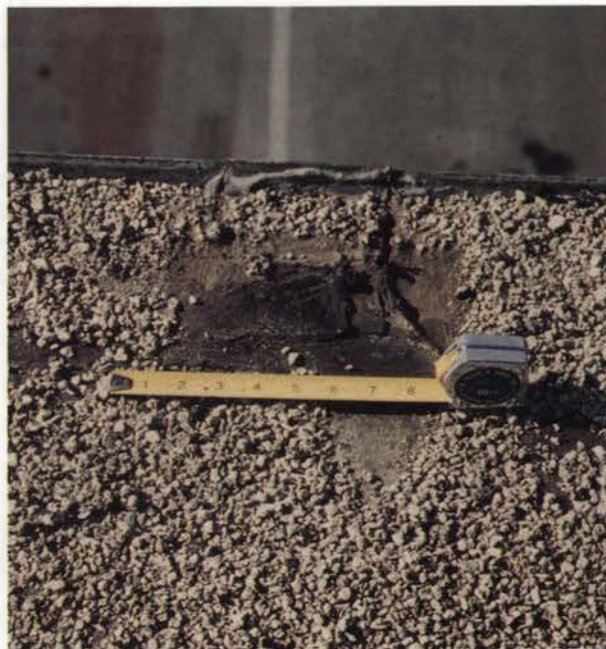
EM6 Embedded Edge Metal  
 <High Severity>  
 The stripping is torn or broken

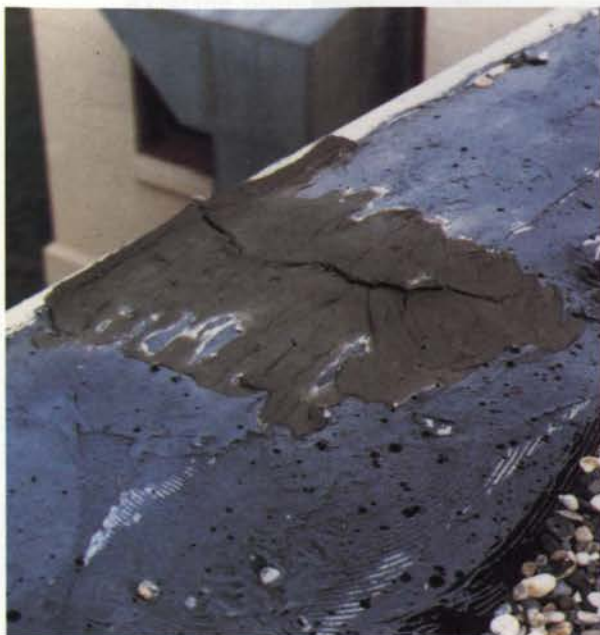
EM7 Embedded Edge Metal  
 <High Severity>  
 The metal movement has torn the stripping

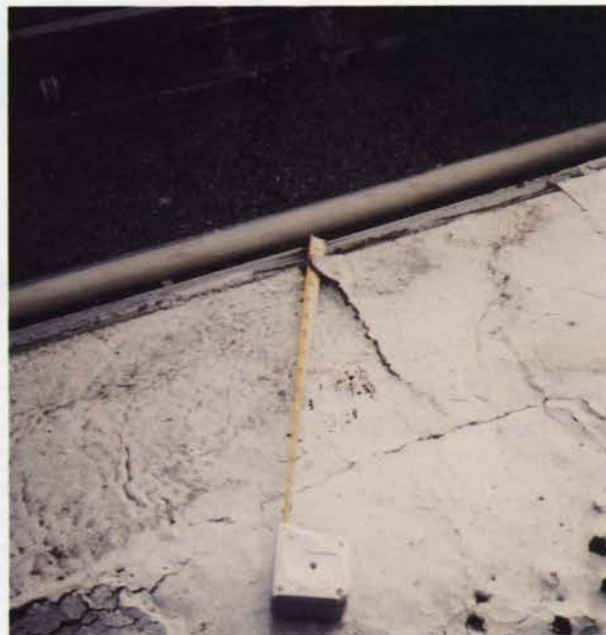
EM8 Embedded Edge Metal  
 <High Severity>  
 The stripping felts are torn
